MARINE SAFETY INVESTIGATION REPORT

Safety investigation into the grounding of the
Togo registered oil tanker

HEPHAESTUS

MARINE SAFETY INVESTIGATION REPORT NO. 03/2018

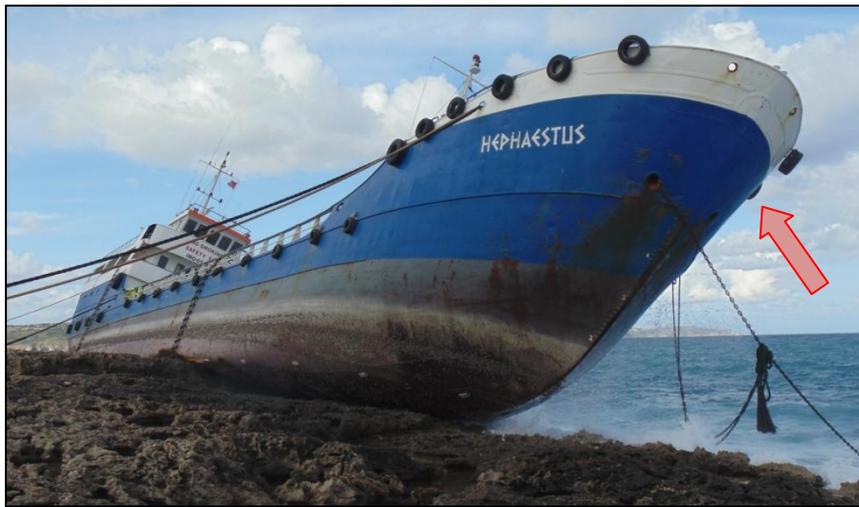
During the course of the safety investigation, the crew members confirmed that the main engine was never started. According to the master, the vessel felt like being hit by a cyclone and she drifted very quickly towards the shoreline, giving the crew members very little time to get the main engine started. No order was given by the master to release of the port anchor to slow down the drift of the vessel. At the time of the grounding, the vessel did not have a port anchor and chain (Figure 6).

Figure 6: *Hephaestus* ground with her port anchor and chain missing

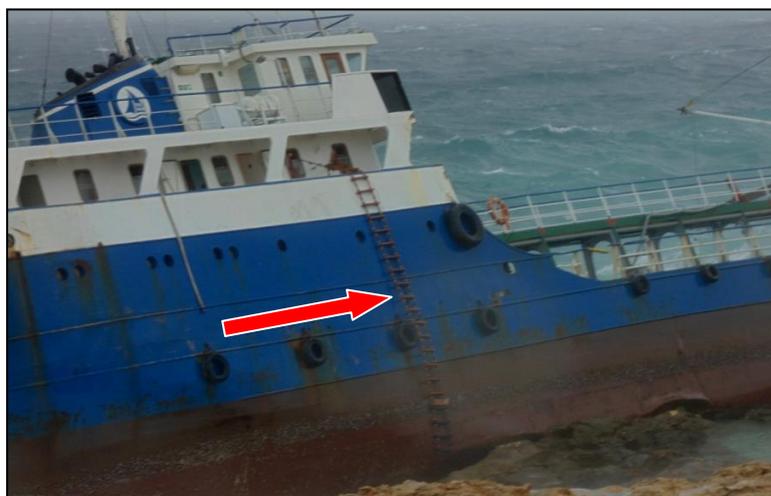
Soon after the ship ran aground, the crew members disembarked from the vessel directly on the rocky shore, using the vessel's pilot ladder (Figure 7) and wearing their lifejackets. They did not make use of other life saving appliances. According to the master, the rescue boat could not be used as this was not stowed in its designated amidships position, but lashed against the forecastle bulkhead.

Figure 7: Pilot ladder secured against the accommodation block

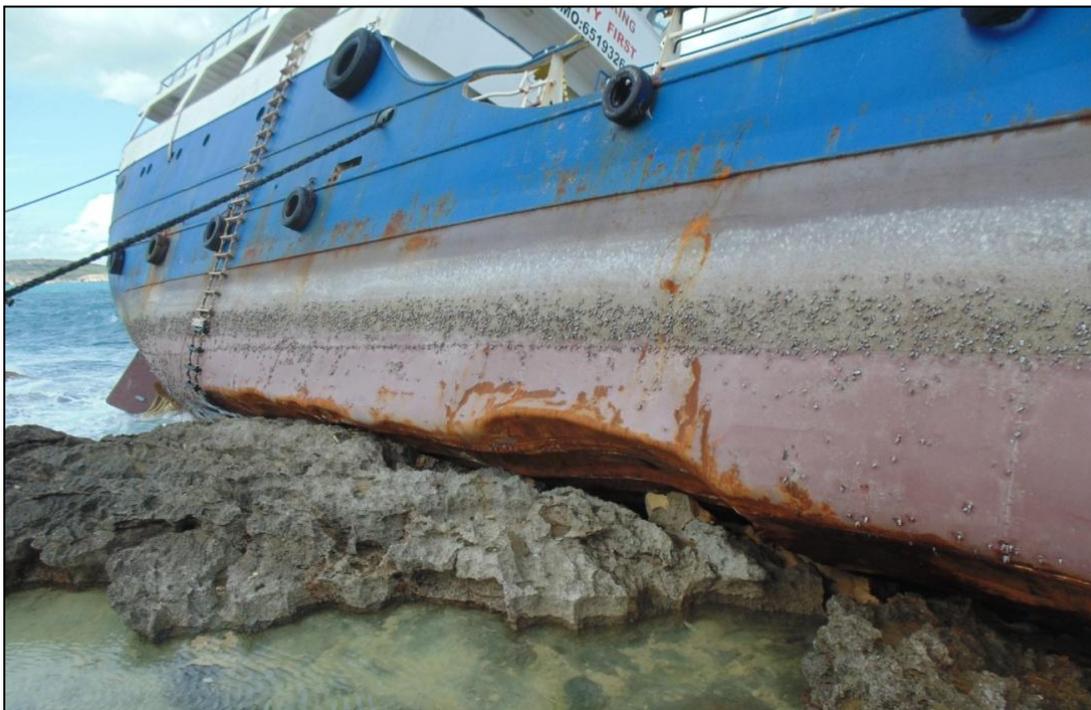
It was evident that the vessel had sustained extensive structural damages as a result of her grounding (Figures 8 and 9). Her starboard side bottom shell plating was deeply set in and buckled with structural damages also to her internal stiffeners.

Figure 8: Bottom shell plating set in following the grounding

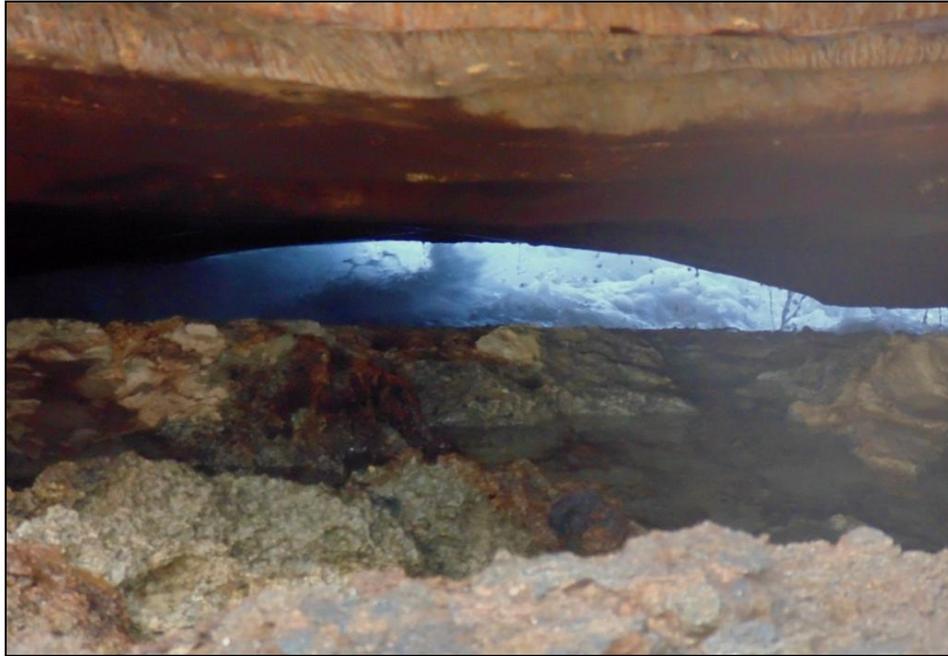
Figure 9: Bottom shell plating damage

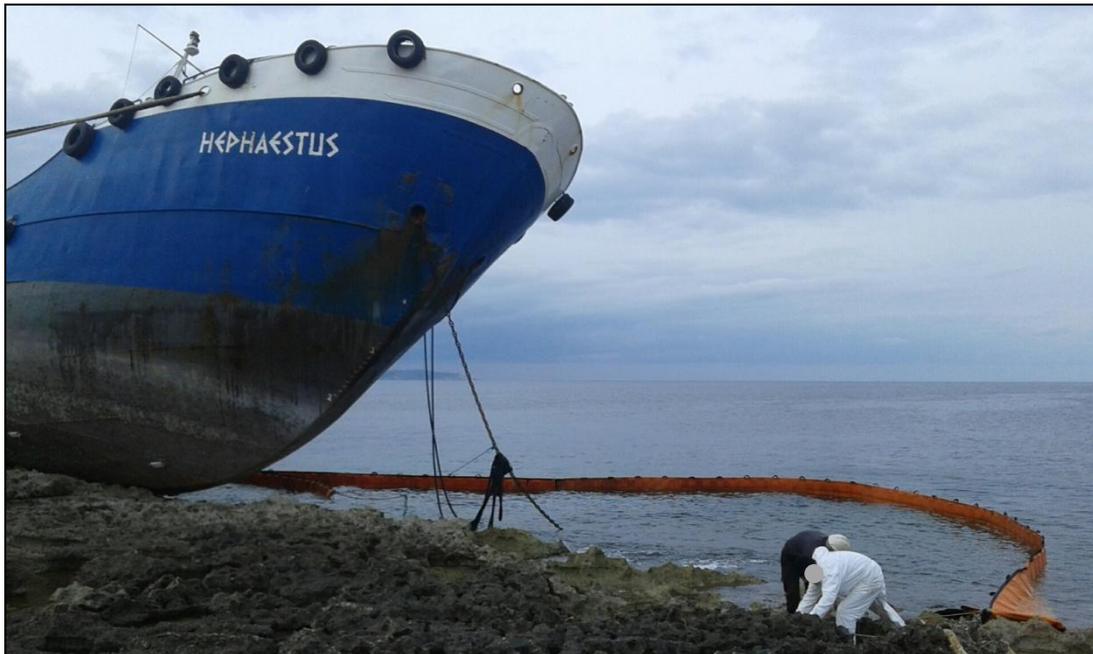
According to the chief engineer, at the time of grounding the vessel had on board around six tonnes of diesel oil in her bunker tanks. Several days after the grounding, a small amount of diesel oil escaped the damaged hull. An oil boom was deployed to contain the spill (Figure 11), which caused damages neither to the surrounding shore line nor to the marine life.

Figure 11: Oil boom being deployed to contain the light oil sheen

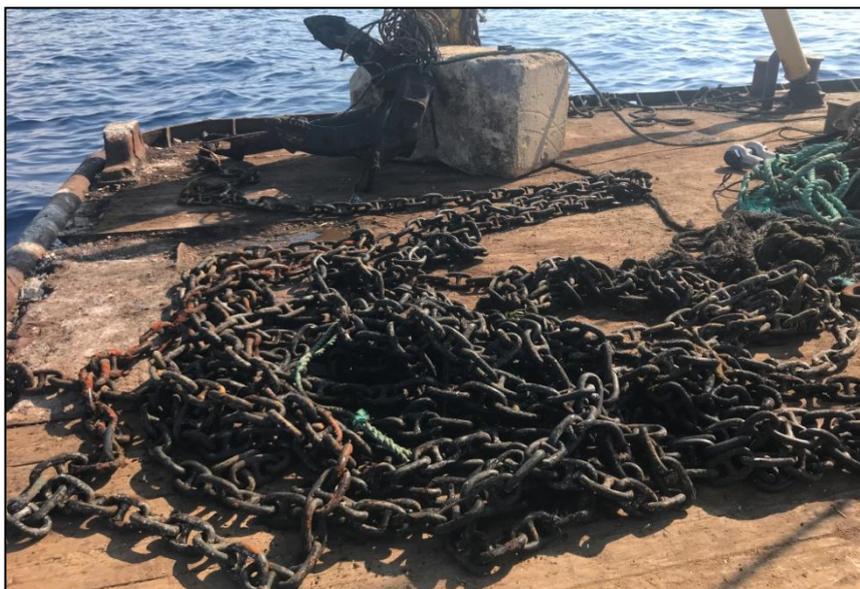
Hephaestus was anchored in water depth of around 49.0 m and hence the vessel should have had a length of 294.0 m of cable laid out in fair weather, while 490.0 m of cable would have been required in inclement weather conditions. However, while the vessel had 4.5 shackles of anchor cable in the water, (which is equivalent to a length of 123.75 m), the vessel was only fitted with approximately 165.0 m (Figure 13). To this effect, the anchor holding power was less effective in this depth.

When *Hephaestus* started dragging her starboard anchor, the remaining anchor cable was not paid out.

Figure 13: Anchor cable and starboard anchor after being retrieved by the salvor

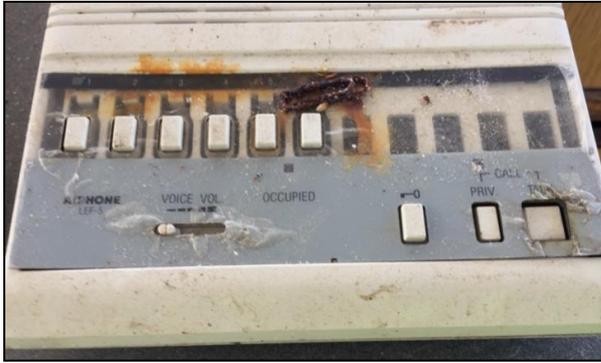
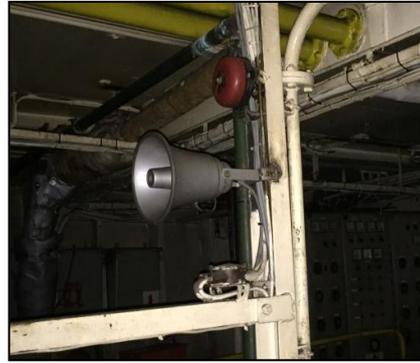
fitted on board (Figures 14a and 14b) was a one-way communication system from the bridge to other areas and not *vice versa*). In fact, when the chief officer eventually requested the chief engineer to start the main engine, the vessel ran aground soon after.

Figures 14a and 14b: PA system on the bridge and PA loudspeaker in the engine-room

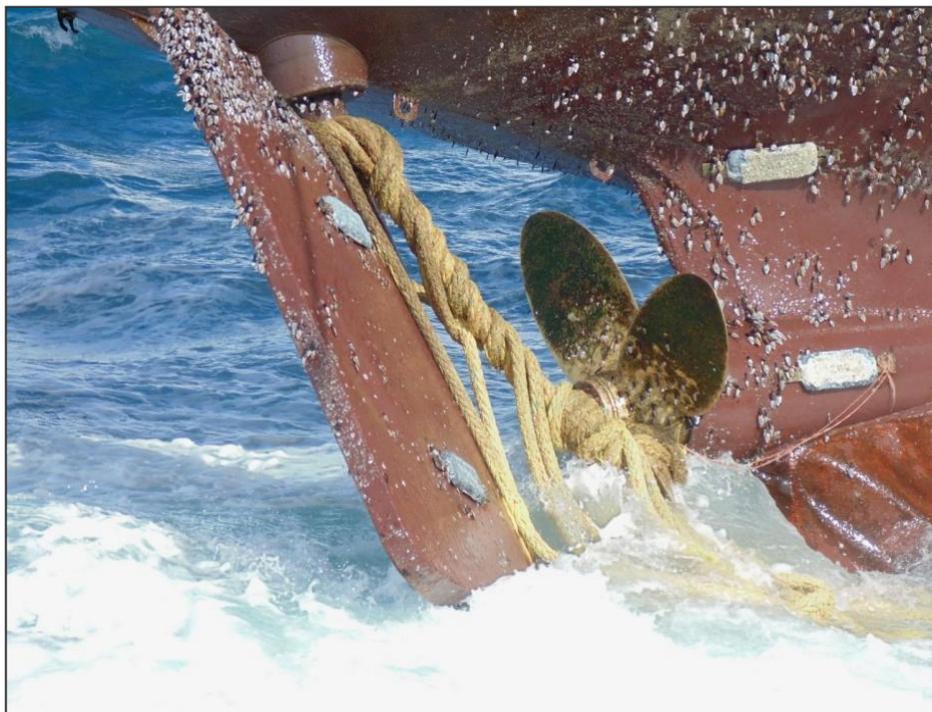
With reference to the propulsion power, the MSIU observed that the rope fouling one of the propeller blades and the rudder stock (Figure 15) was actually a mooring rope which may have been lost from *Hephaestus*' poop deck. While it was not possible to determine at what stage the mooring rope was lost overboard, this did not have a bearing on the outcome of the events, given that the main engine was not started prior to the grounding.

Figure 15: Mooring rope fouling one of the propeller blades and the rudder stock

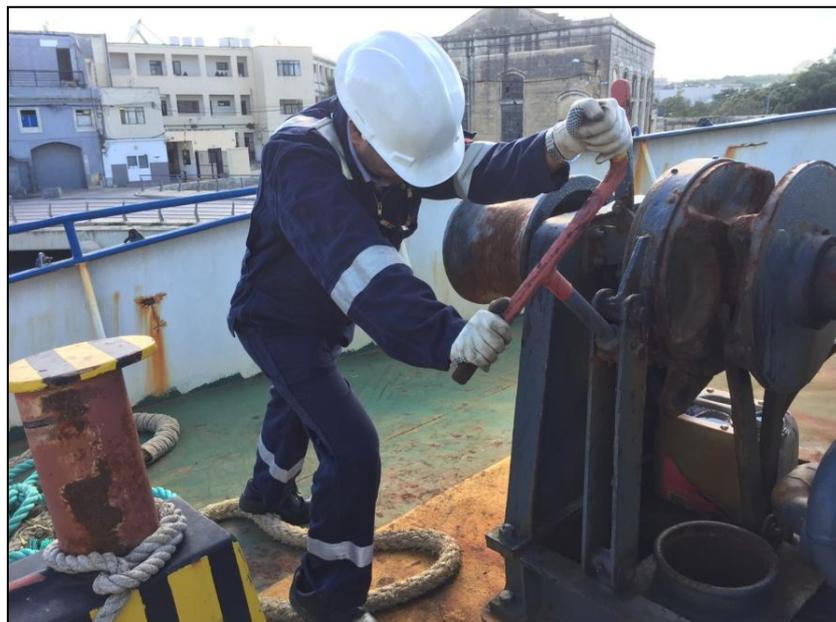
After the vessel was refloated, MSIU safety investigators went on board and further to the missing port anchor and chain, they also found that the port anchor windlass brake was jammed closed (Figure 16) but with no indications of fresh damages which, perhaps, would have been indicative of anchor chain slippage (Figure 17).

Figure 16: Jammed port side windlass brake

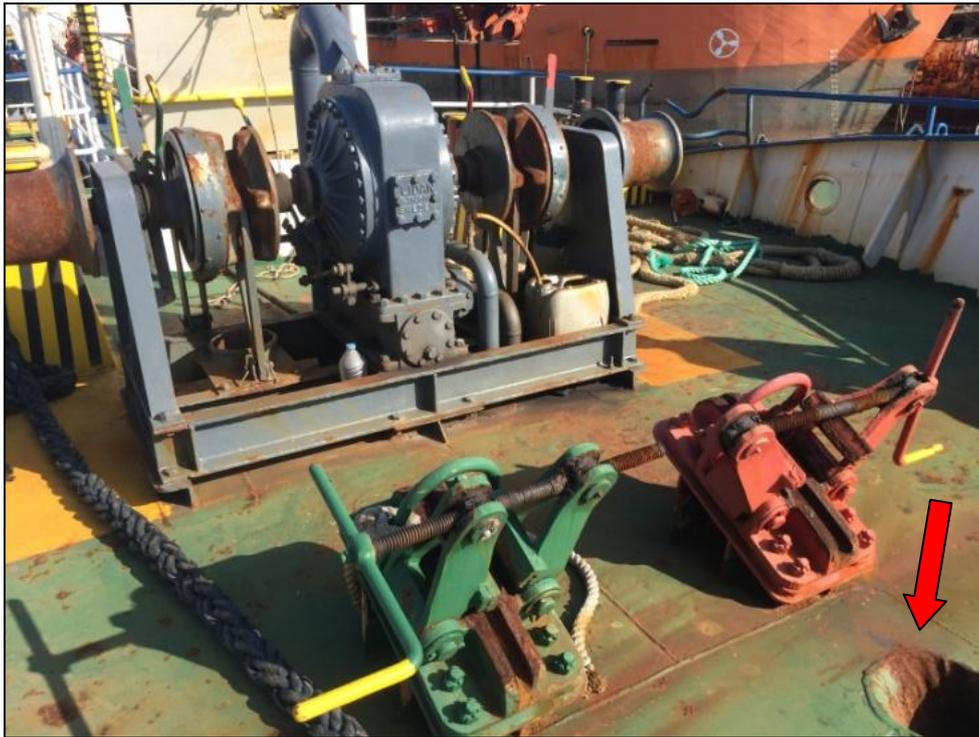
Figure 17: No visible fresh damages on the port side hawse pipe

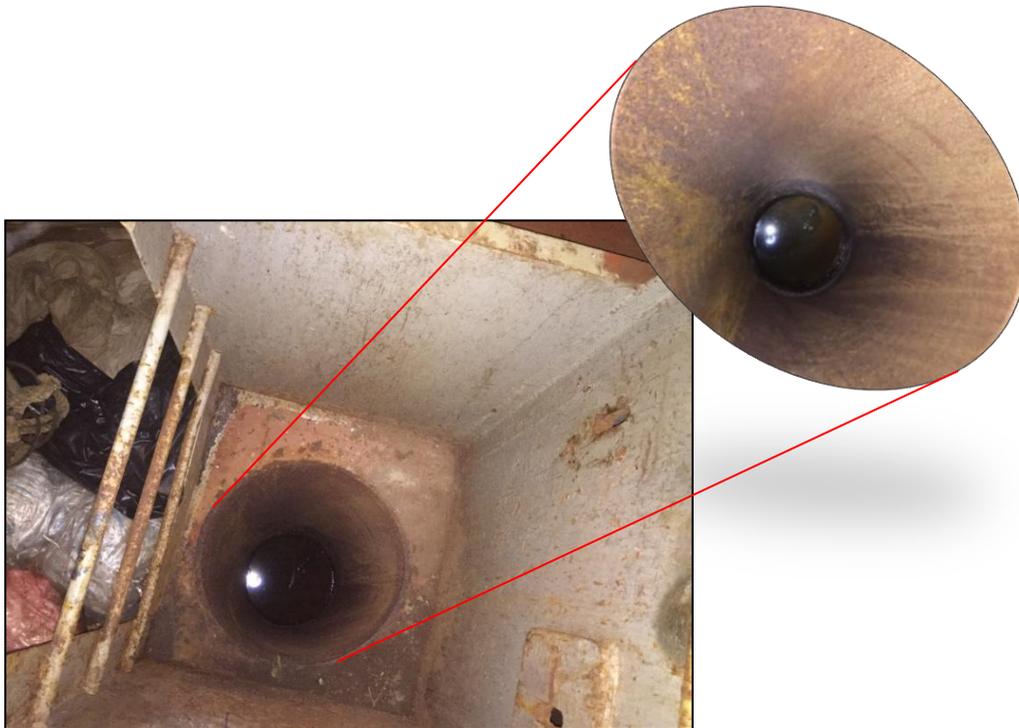
The safety investigators did not have access to the chain locker due to the relatively small diameter and the presence of water and mud. The MSIU was therefore unable to inspect the condition of the bitter end on the port side (Figure 18).

Figure 18: Port side chain locker
