MARINE SAFETY INVESTIGATION REPORT

Safety investigation into the grounding of the
Togo registered oil tanker

HEPHAESTUS

MARINE SAFETY INVESTIGATION REPORT NO. 03/2018

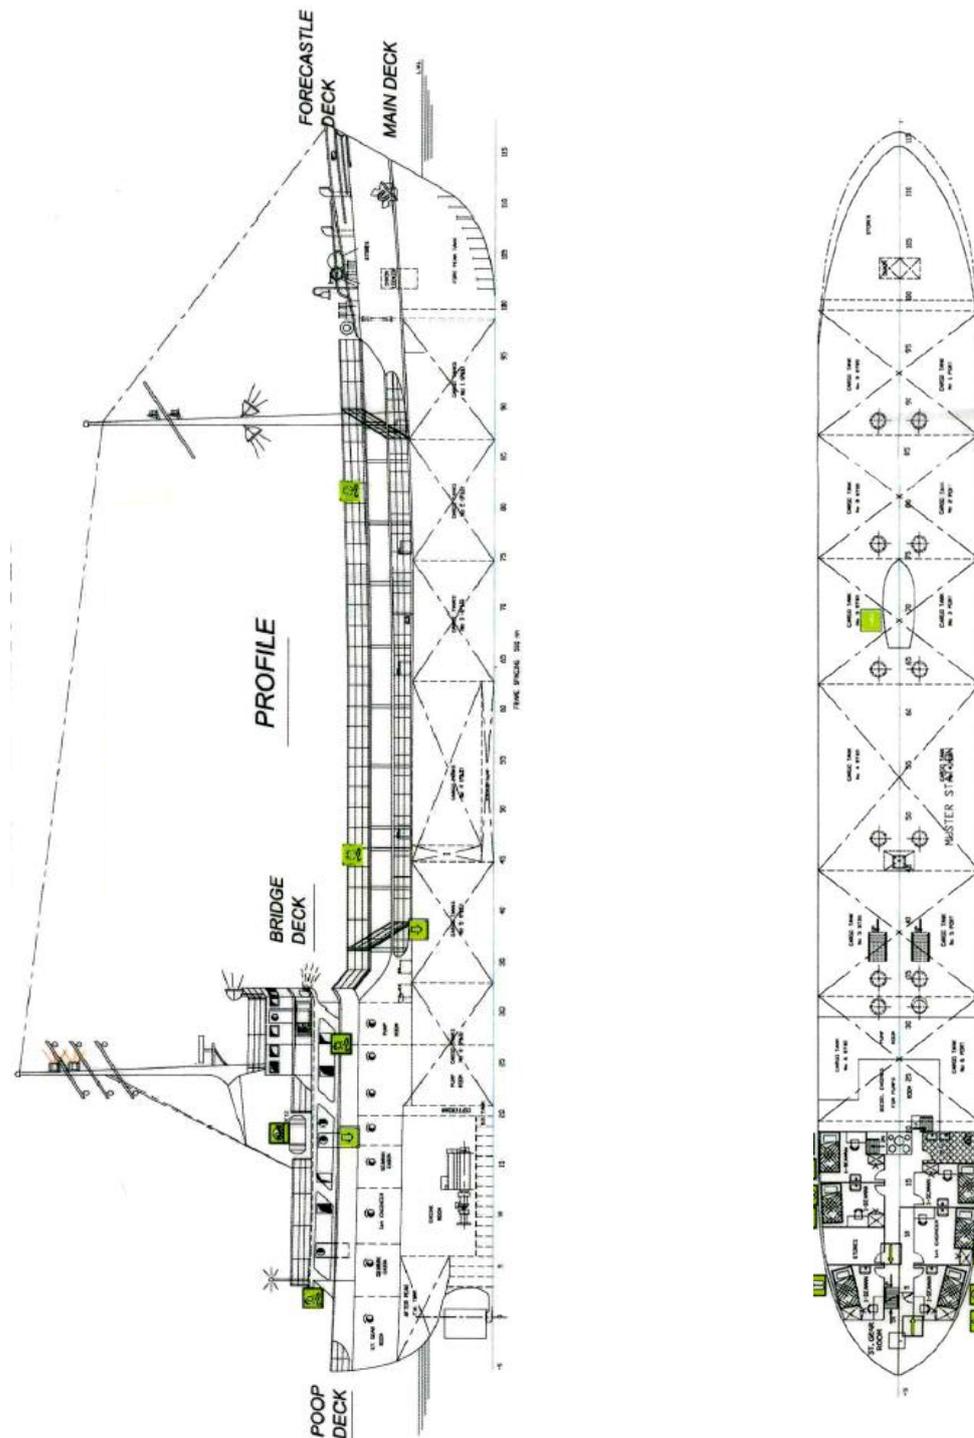
Figure 1: MT *Hephaestus*

Hephaestus, a 595 gt oil tanker (Figure 1) was built in 1965 by Broderna Jonssons Torrdocka (Kallandsö Varv AB), Linköping, Sweden and was registered in Togo. She was owned by Orbiter Navigation Corp., managed by Volont Maritime S.A., and was classed by the International Naval Surveys Bureau (I.N.S.B.).

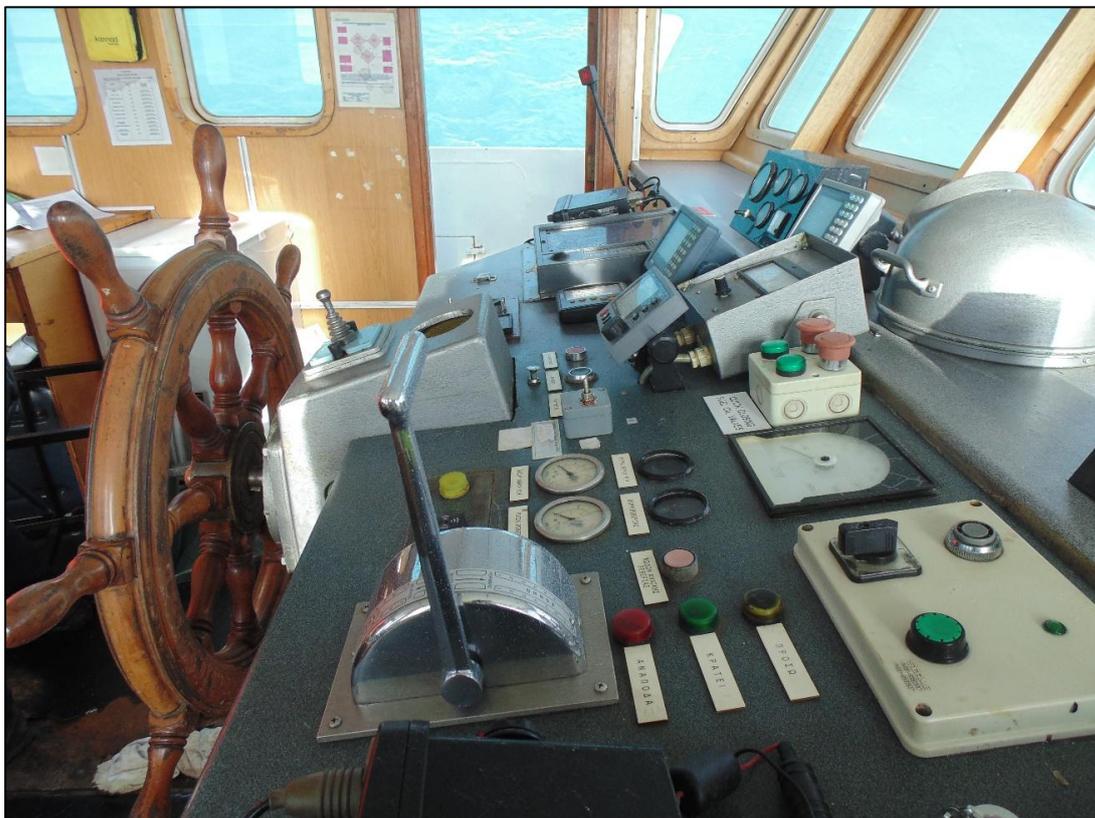
Figure 2: Main navigation console on the bridge

The navigation bridge layout was a conventional and a standard one for the type and size of this vessel (Figure 2). The console, which included the magnetic compass, the radio communications, AIS, NAVTEX, engine controls, autopilot and hand steering position, was located at the forward end of the bridge, right beneath the bridge windows (Figure 3). The radar was located on the port side of the bridge.

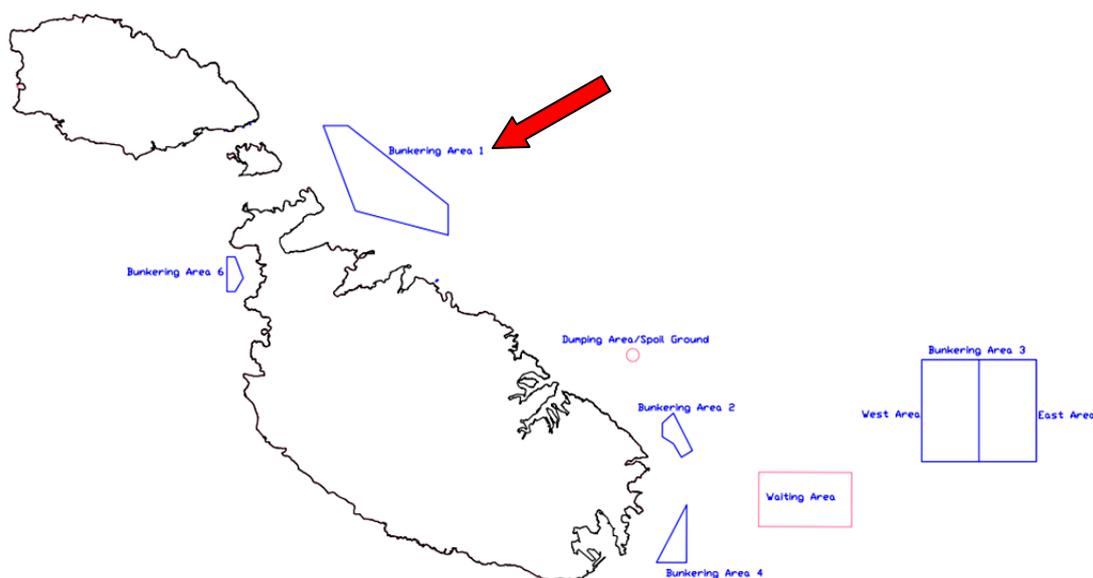
Figure 4: Designated bunkering areas around the Maltese Islands

Hephaestus arrived off Malta on 19 September 2017 and dropped anchor at Hurd Bank at 1010. Due to adverse Northwesterly (NW) weather conditions on the following day, the vessel had to heave up her anchor and remained drifting off Malta. *Hephaestus* then requested Valletta VTS permission to take shelter on the leeward side of the island. By 1530, *Hephaestus* dropped anchor in Bunkering Area No. 1 in position 35° 59.39' N 014° 24.09' E² (Figure 4).

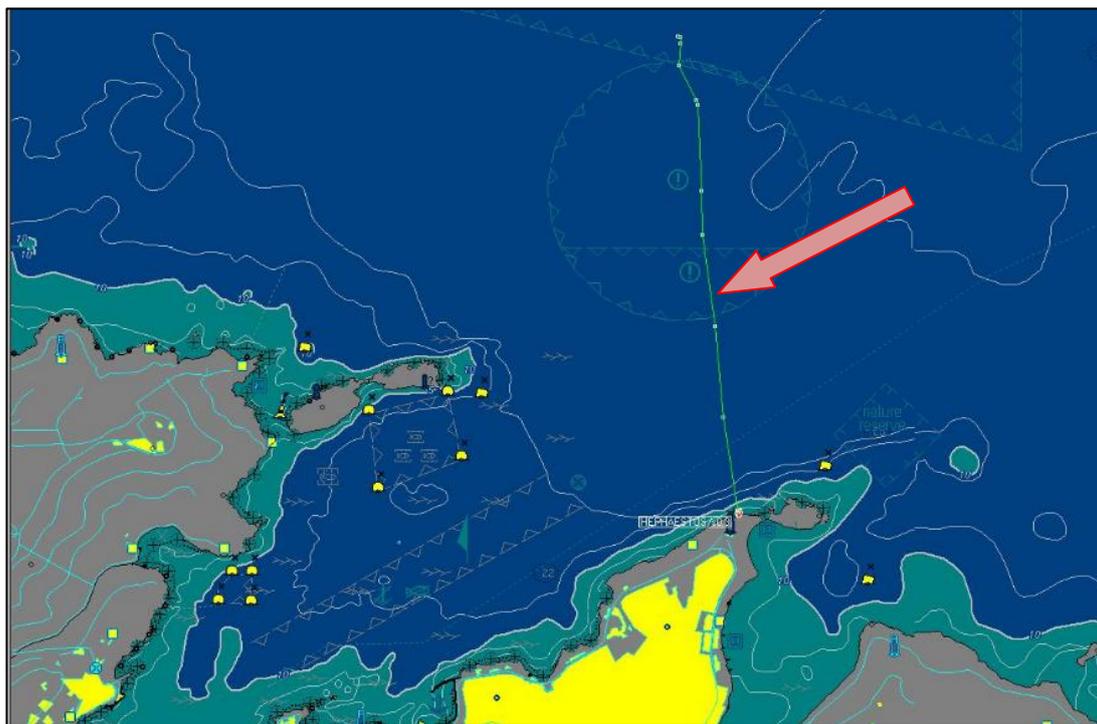
Figure 5: Hephæstus AIS track

By 0611, the Northerly wind backed to Northwest by North was gusting to Force 10. Valletta VTS called again the vessel and again warned the master that he was running into danger and that he had to manoeuvre further out or drop the second anchor. Valletta VTS also asked the master if he required any assistance but the master replied again that he needs five minutes to start the engine. At this point, Valletta VTS informed the master that in five minutes time, his ship would be on the rocks. The vessel ran aground at about 0615 in position $35^{\circ} 57.62' N$ $014^{\circ} 25.51' E$, heeling heavily to her port side. The vessel's AIS track throughout this period is shown in Figure 5 and tabulated in Table 3¹¹.

¹¹ The vessel dragged her anchor through a partially dismantled fish farm. This will be discussed in more detail in sub-section 2.4.4.

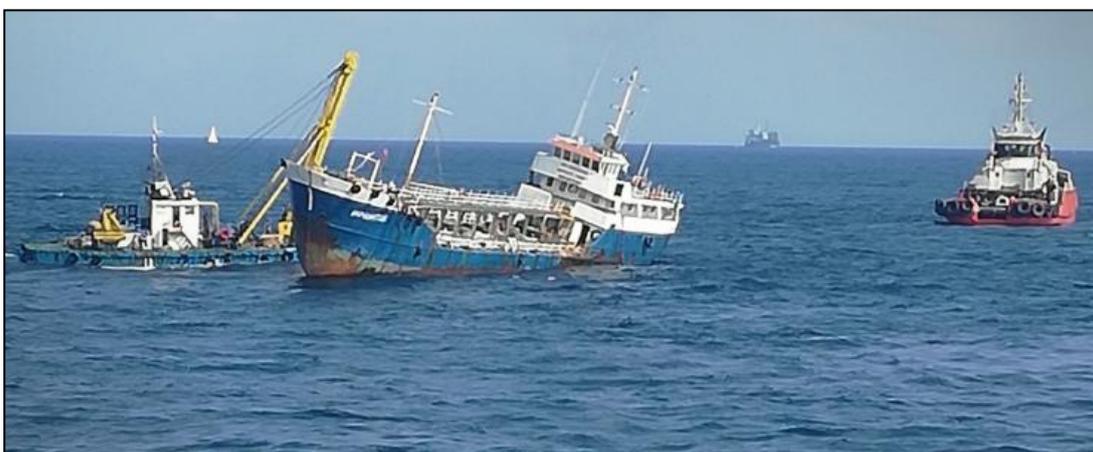
Figure 12: *Hephaestus* afloat

Following the necessary temporary repairs carried out by a local ship repair company, the vessel was eventually pulled off the rocks and refloated on 15 August (Figure 12).

During the preparation for the refloating operation, and after the vessel was afloat again, the salvors made no attempts to start the main engine. Hard aground, the vessel had lost her supply of compressed air for the control and starting systems. Moreover, one of the generators was found dismantled as a result of the grounding and the main electrical panel was submerged in water.
